Jerry Jubert Home Inspection

Your Property Inspection Report

12925 Oliver Ave. S, Maple Grove MN, 55312
Inspection prepared for: Dan Johnson
Inspection Date: 4/7/2011 Time: 1:30 pm
Age: built in 1982 Size: 1496 sp ft
Weather: over cast
Unoccupied at the time of inspection.
Water turned off.

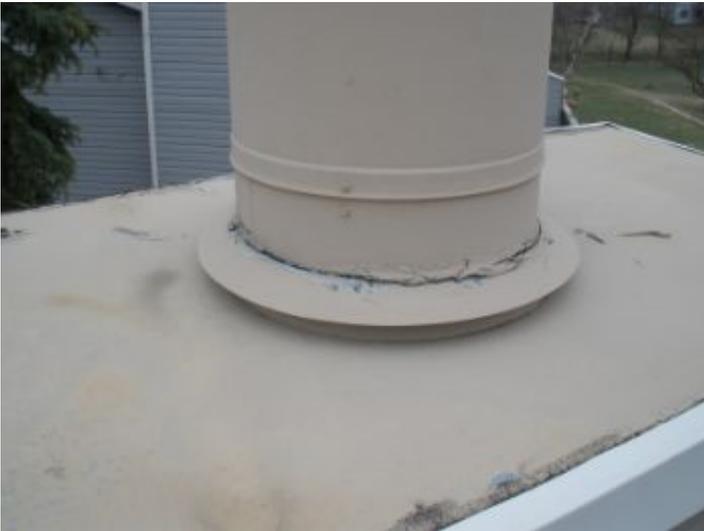
Caulk has deteriorated around metal chimney top.

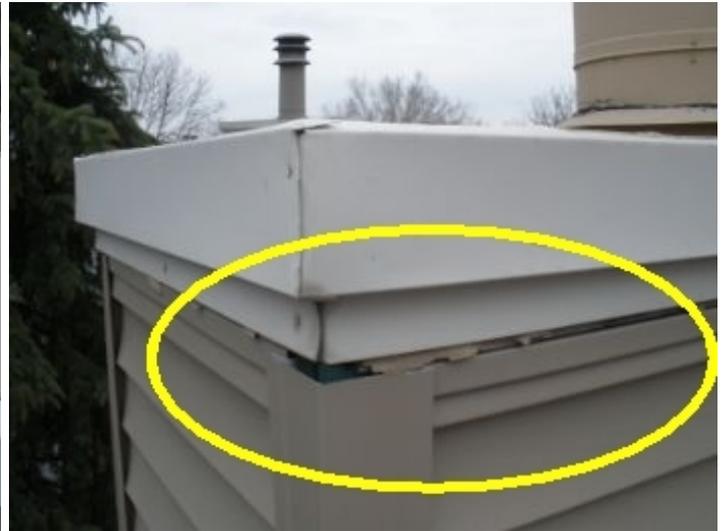
Vinyl siding at top of Chimney loose or not installed correctly.

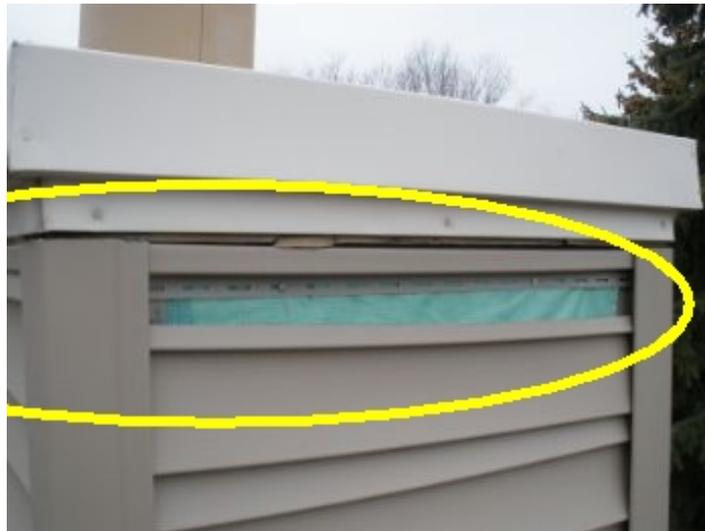
Vinyl siding at top of Chimney loose or not installed correctly.

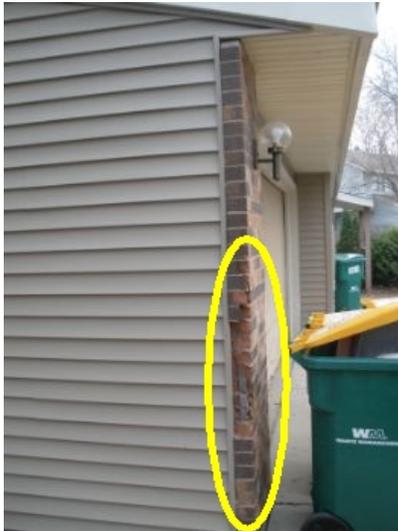
Brick are broken

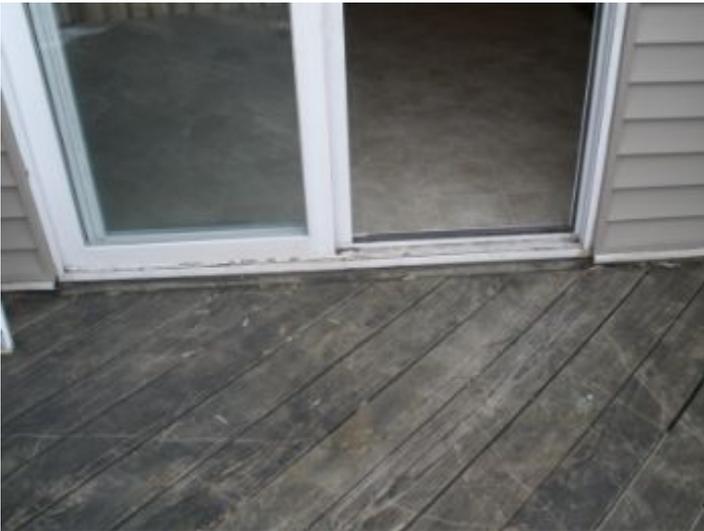
Missing flashing under patio door. Install flashing or caulk and monitor.

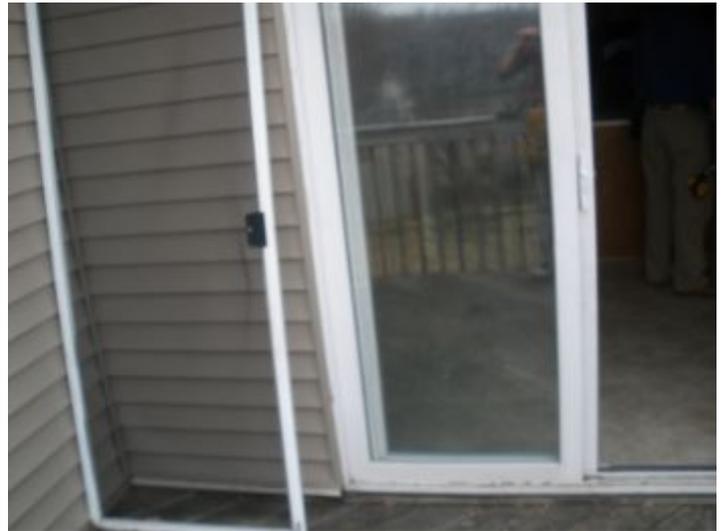
Deck door screen is detach.

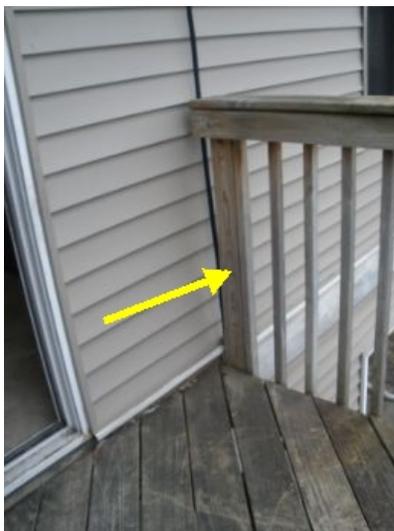
Post loose

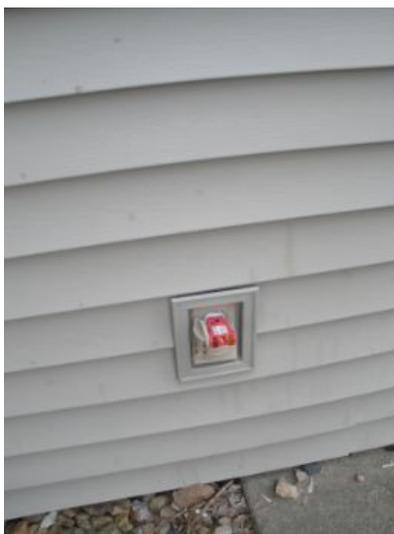
GFCI trip test failed out side back of house, in side garage

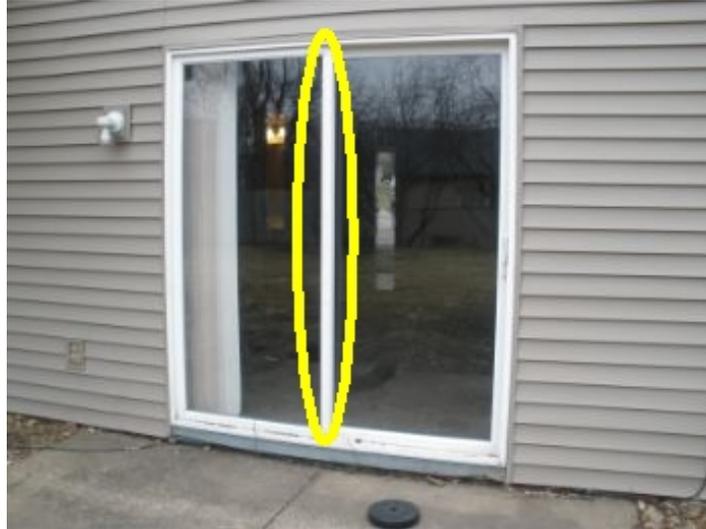
Basement patio door weather strip missing look like wrong size door was replaced.

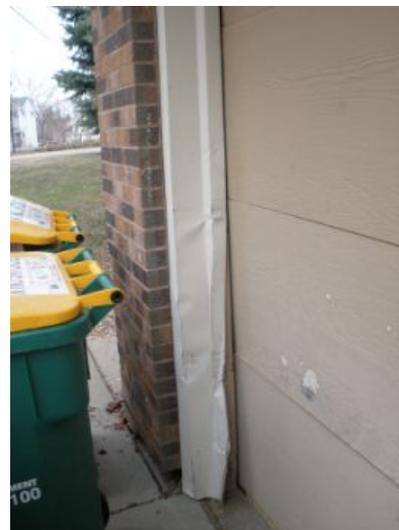
Damage on Left side of garage door

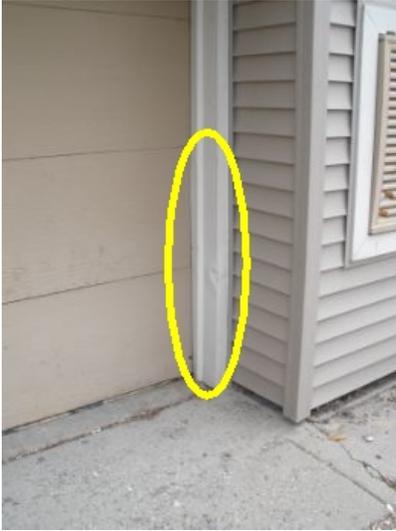
Right side of garage

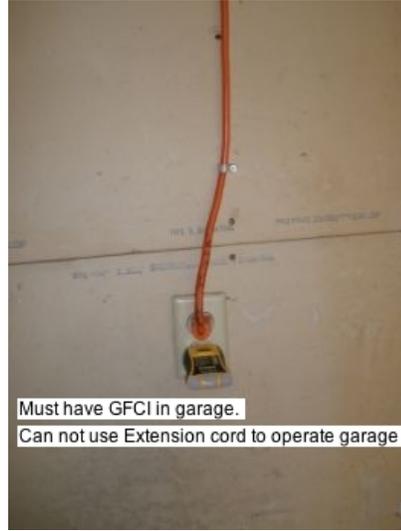
Must have GFCI in garage.
Can not use Extension cord to operate garage

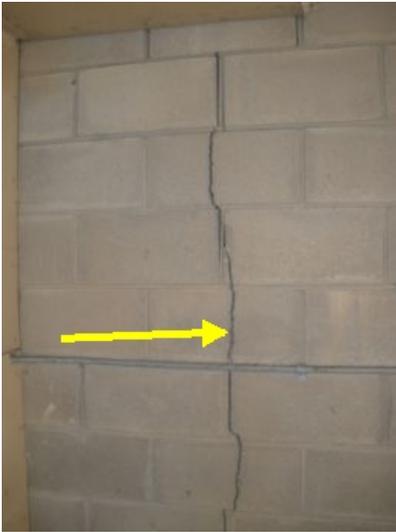
Some movement less than 3/8" watch and maintain

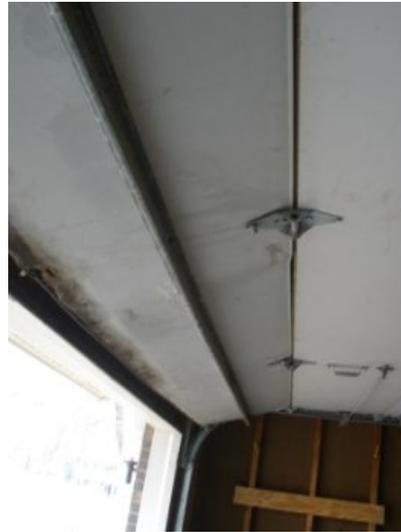
Garage vehicle door panels damaged.

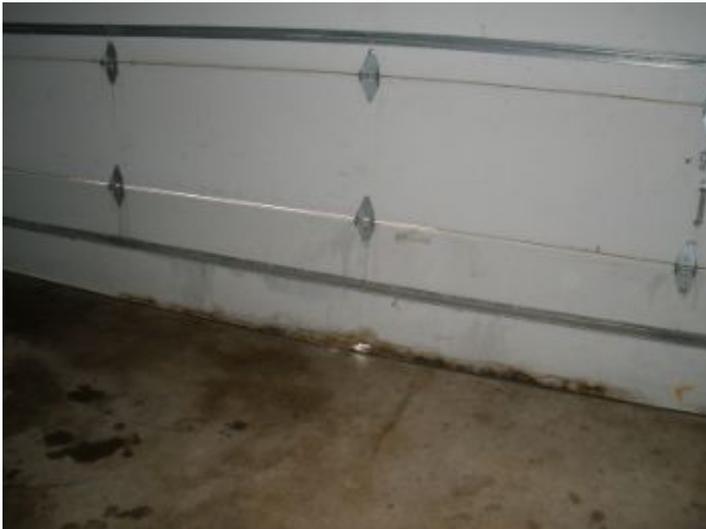
Garage vehicle door panels damaged.

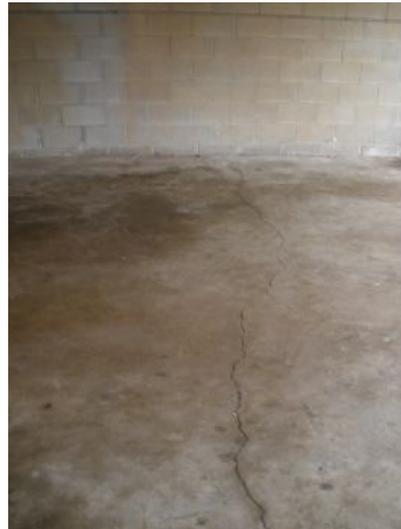
Moderate crack(s) on garage floor. These should be sealed and monitored for expansion.

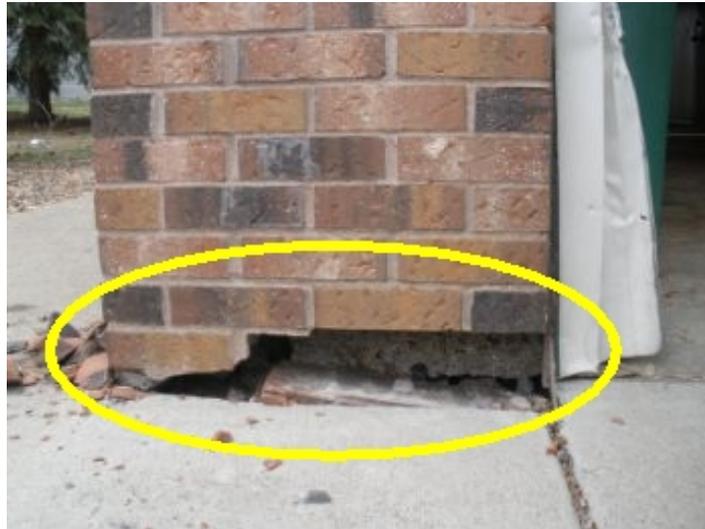
Bricks have been take out.

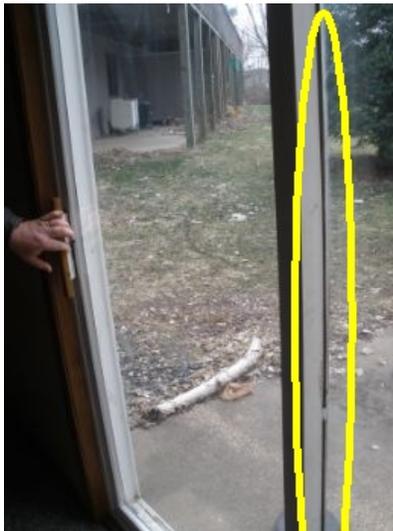
Basement patio door weather stripping missing

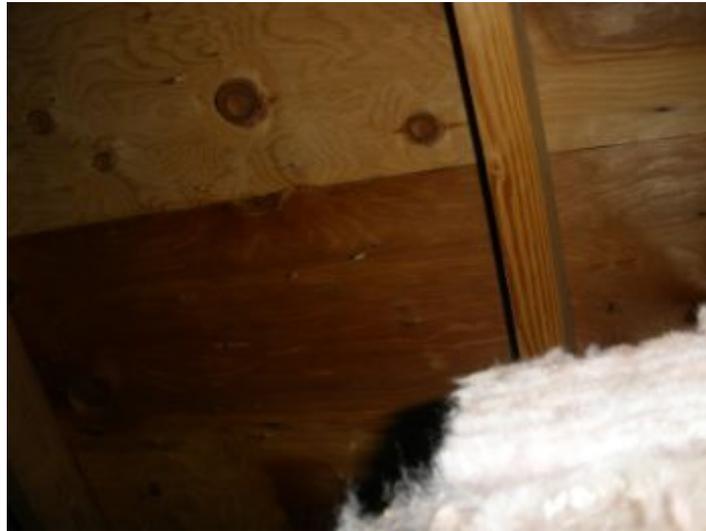
At the time of construction the roofers omitted the "H" clips they separate the sheathing for support as they are for proper spacing to allow for expansion and contraction, as well as stiffen up the roof itself.

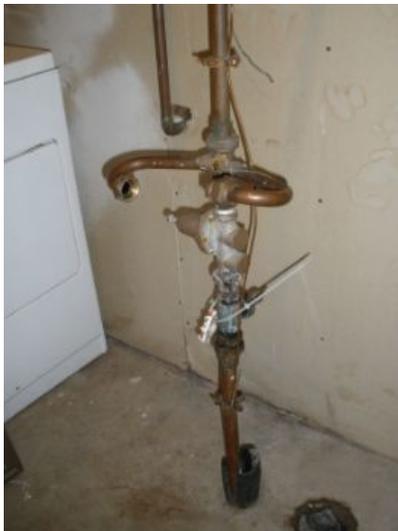
Water turned off on Meter.

- - No water, could not test unit. Have seller or representative turn unit on and verify proper operation in time for Buyer's Final Walk-Through, prior to closing.

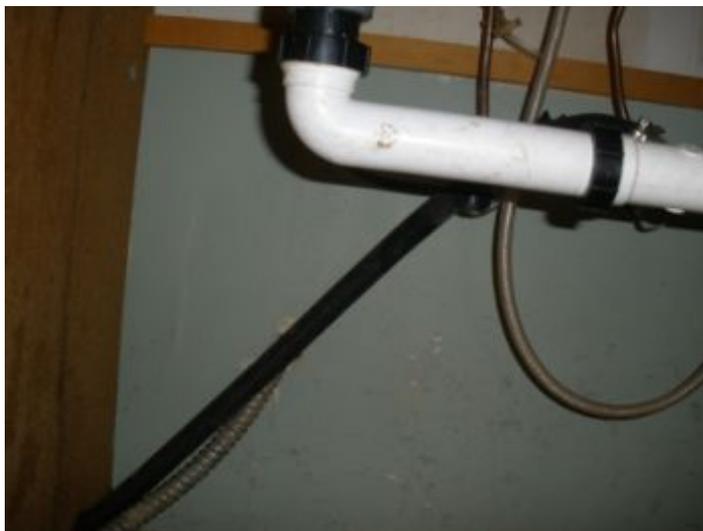
Dishwasher does not have proper hi, an anti-siphon loop is a pipe with an 'U' shaped must loop above dishwasher in to 'Y' pipe before 'P' trap. The reason as to why he recommended you to install is that it is to prevent any back flow of water between the kitchen sink and dishwasher or visa-versa.

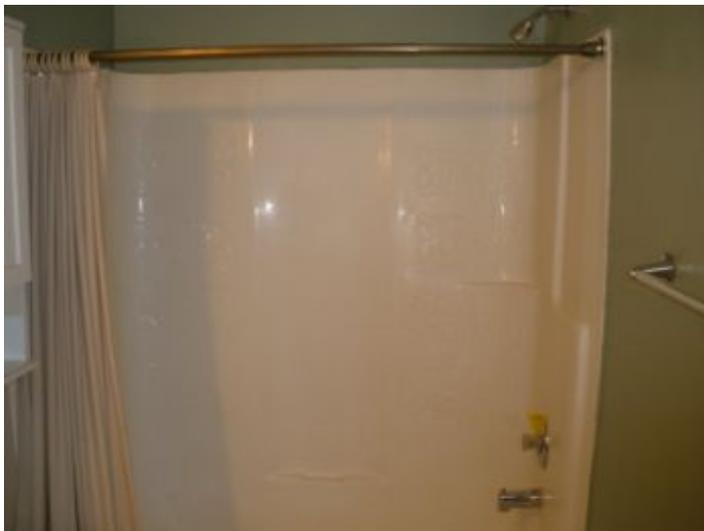
Water turned off could not check sink, tub or toilet.

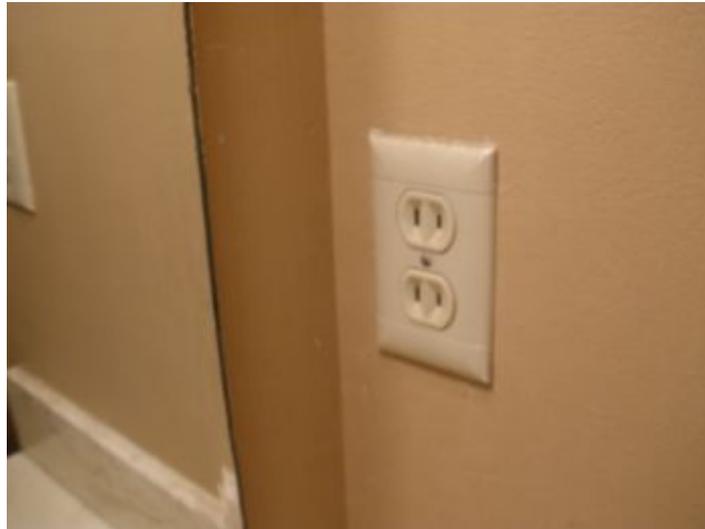
Need GFIC in basement bathroom.

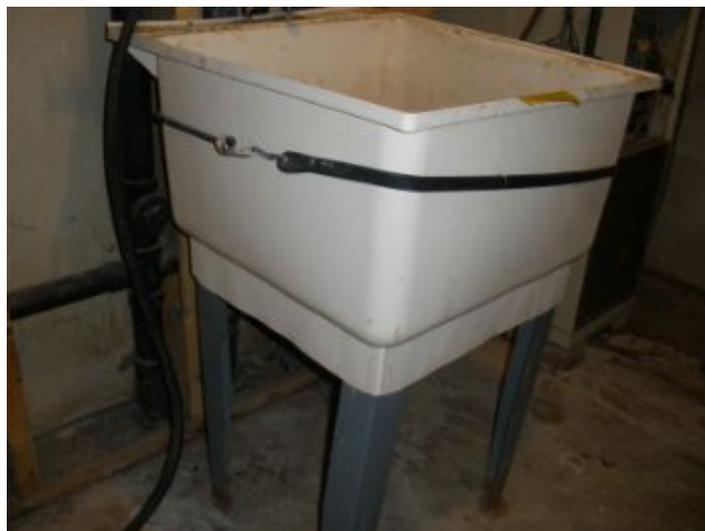
Laundry sink is has bungee cord wrap around it for support.

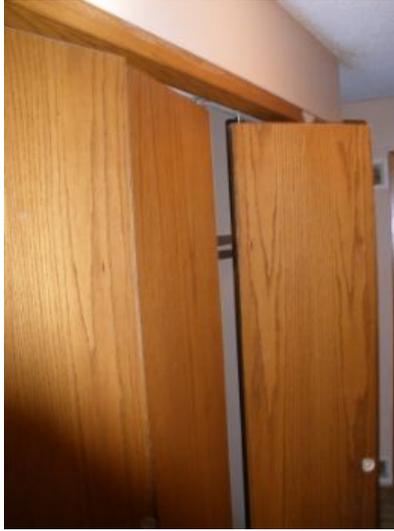
Door by front door off track.

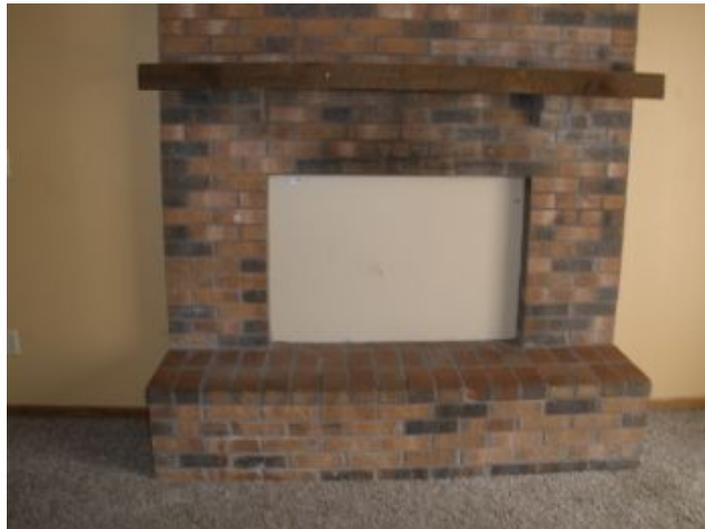
- Fireplace was blocked off could not inspected. Not functional.

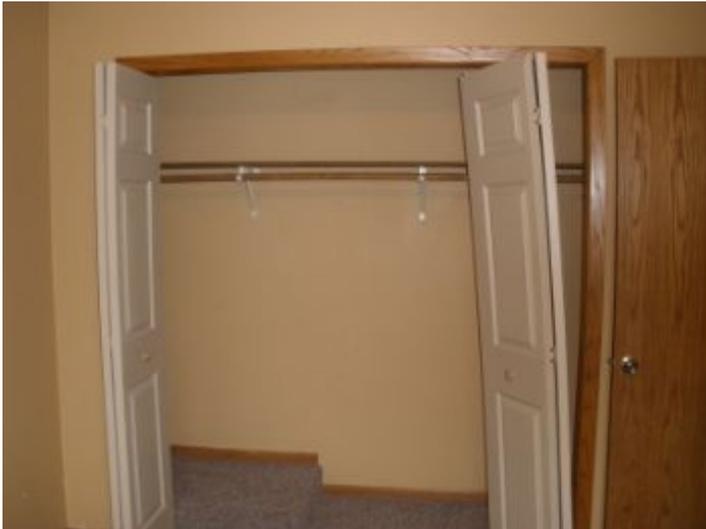
Closet doors are damaged.

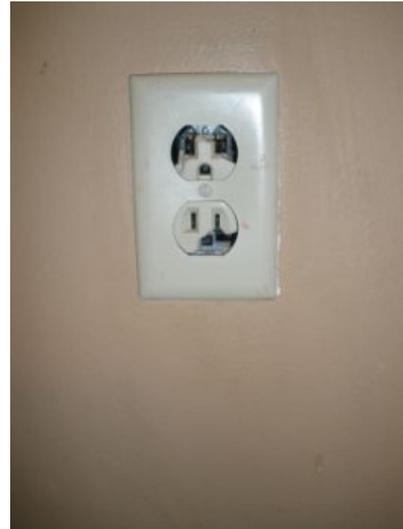
Out let damage

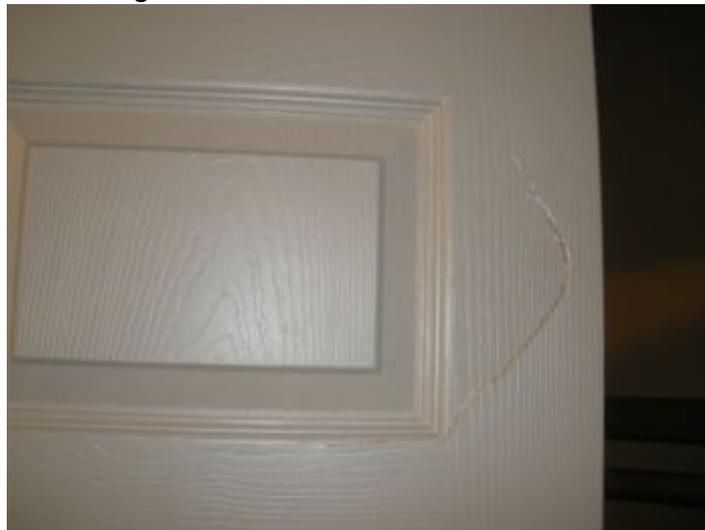
Closet doors are damaged.

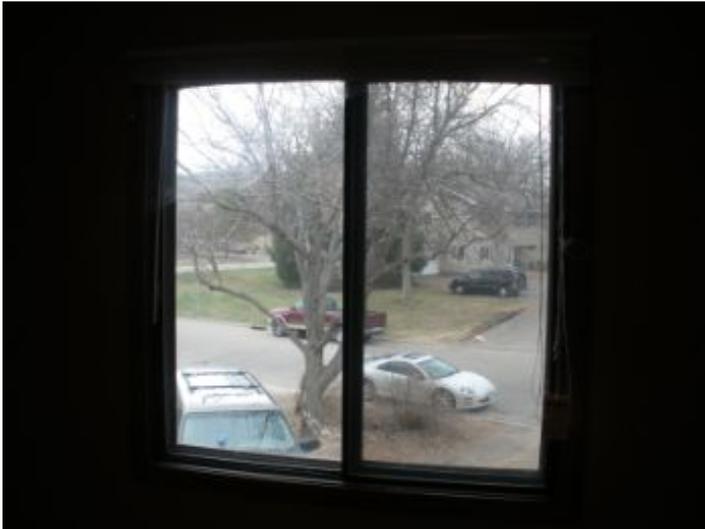
Screen missing on window.

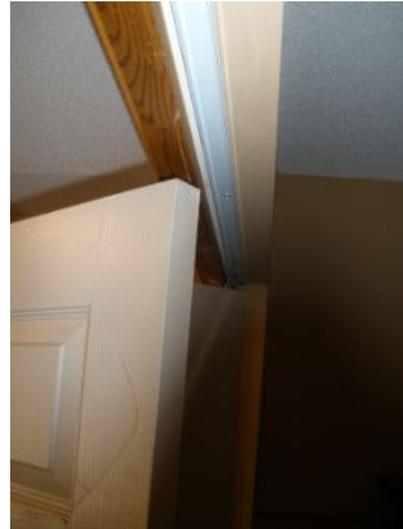
Closet doors are damaged.

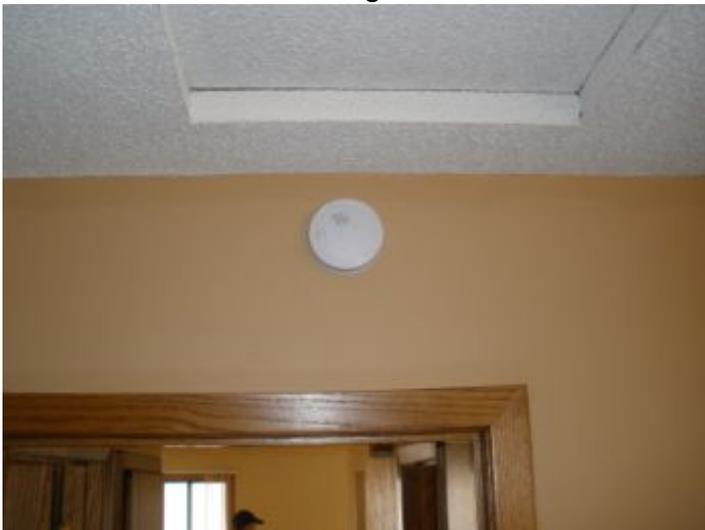
Smoke and carbon monoxide detectors improperly installed in bedrooms, recommend to reinstalling; must be at least one foot from corner of room best to mount on ceiling.

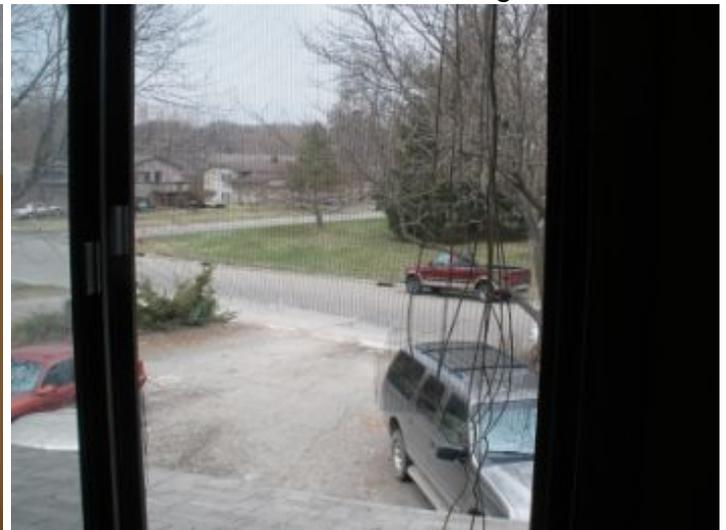
Screen missing on window.
