Jerry Jubert Home Inspection

Your Property Inspection Report

12925 Oliver Ave. S, Maple Grove MN, 55312
Inspection prepared for: Dan Johnson
Inspection Date: 4/7/2011 Time: 1:30 pm
Age: built in 1982 Size: 1496 sp ft
Weather: over cast
Unoccupied at the time of inspection.
Water turned off.

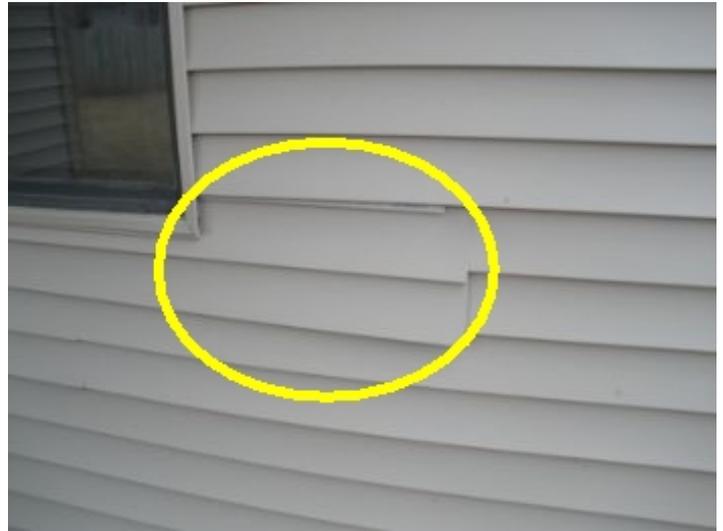
- There are 2 layers of siding the top in Vinyl siding.
- Vinyl siding need to be fixed on back of unit.
- On front - left side of garage bricks broken out at the bottom and on the left side see photos.

Brick are broken

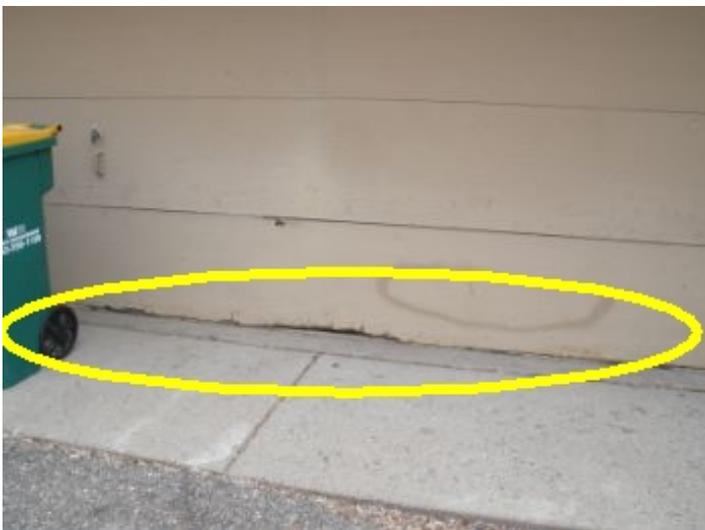
- Garage Vehicle door weatherstripping is damaged.
- Garage door right and left sides are damage.
- Garage door opener cannot have extension cord to operate;

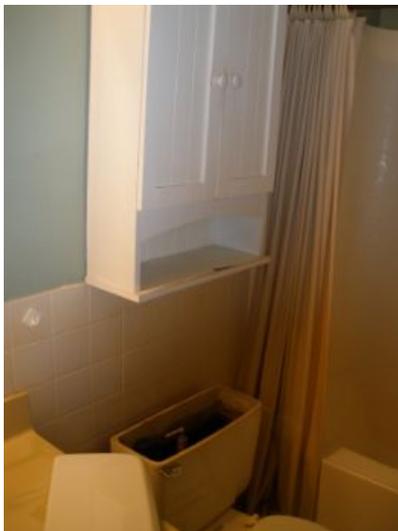
- LOCATION: Main floor Full, water turned off.
- Water turned off could not check sink, tub or toilet.

Water turned off could not check sink, tub or toilet.
